LATROBE RESERVOIR

PHASE I INSPECTION REPORT.

6 NATIONAL DAM INSPECTION PROGRAM. ✓

PHASE I INSPECTION REPORT
NATIONAL DAM INSPECTION PROGRAM
LATROBE RESERVOIR
NDI# PA-479, PENNDER# 65-66

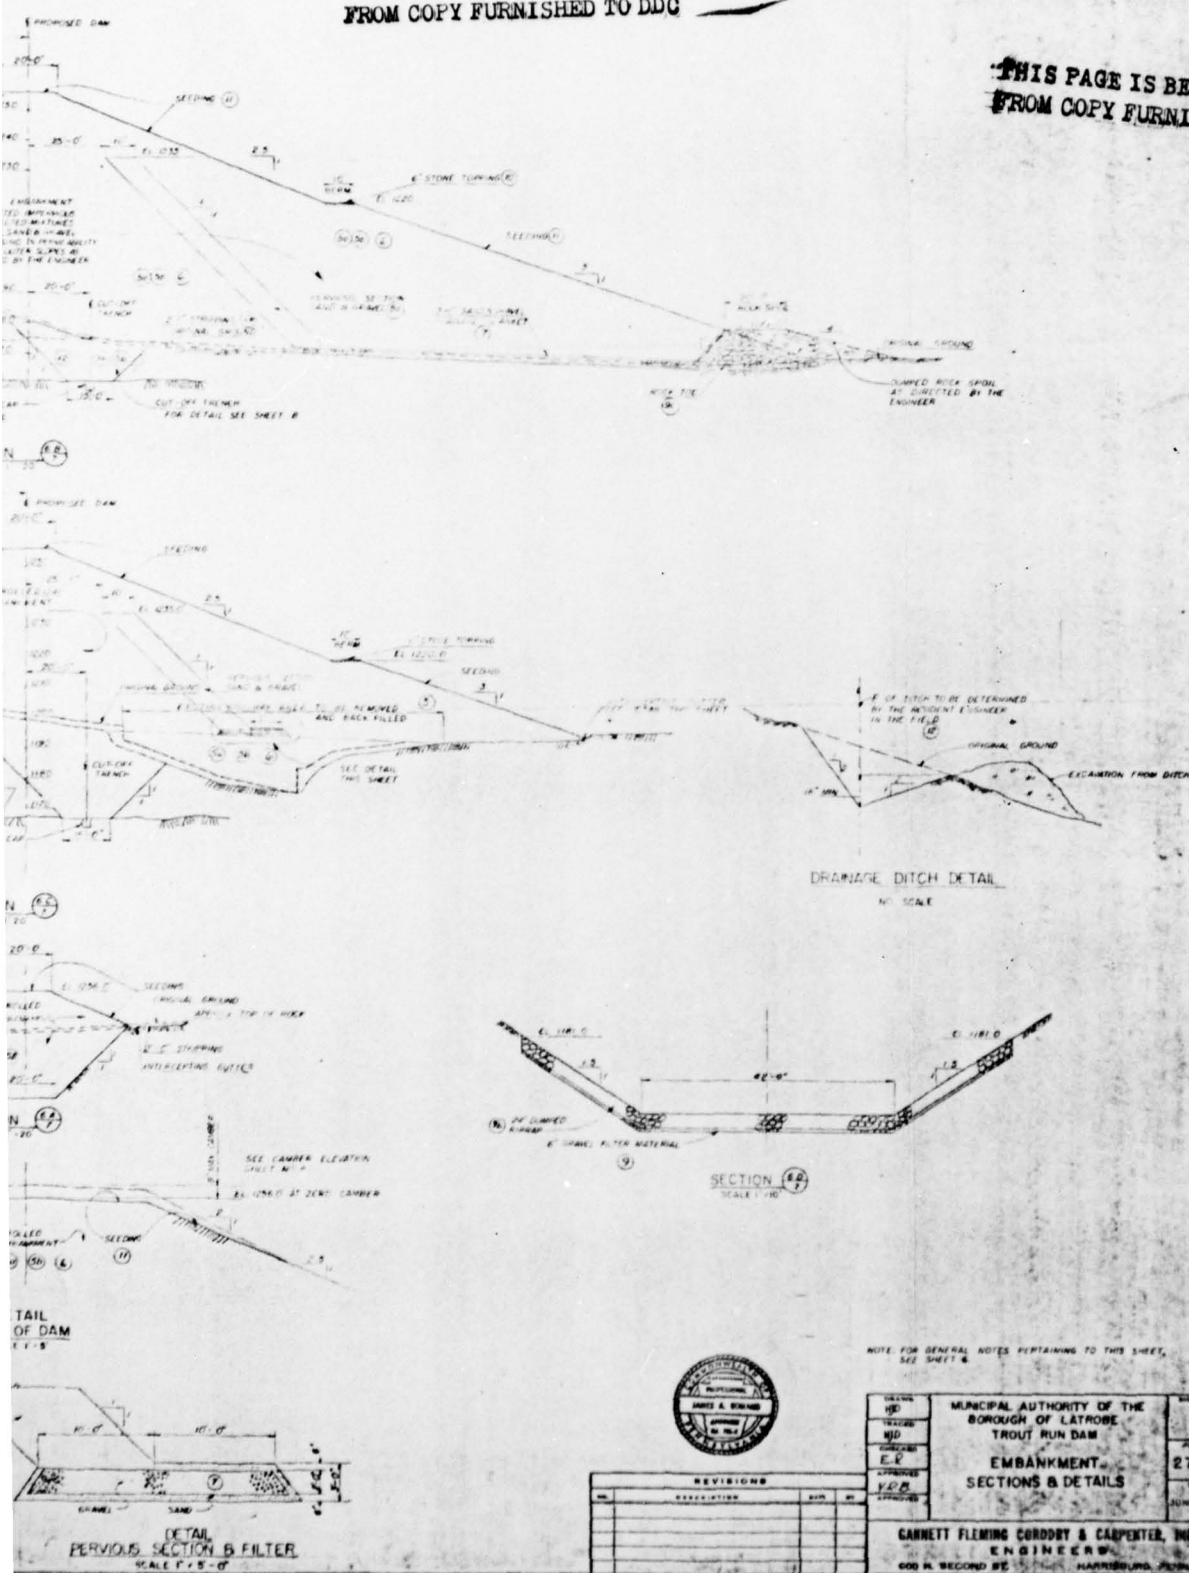
FIGURE 3

Zoning - Compacted impervious selected mixture of clay, sand, and gravel increasing in permeability toward outer slopes, with riprap on upstream face, and rock toe downstream. A sand and gravel filter blanket is provided within and beneath the embankment (see Figure 3).

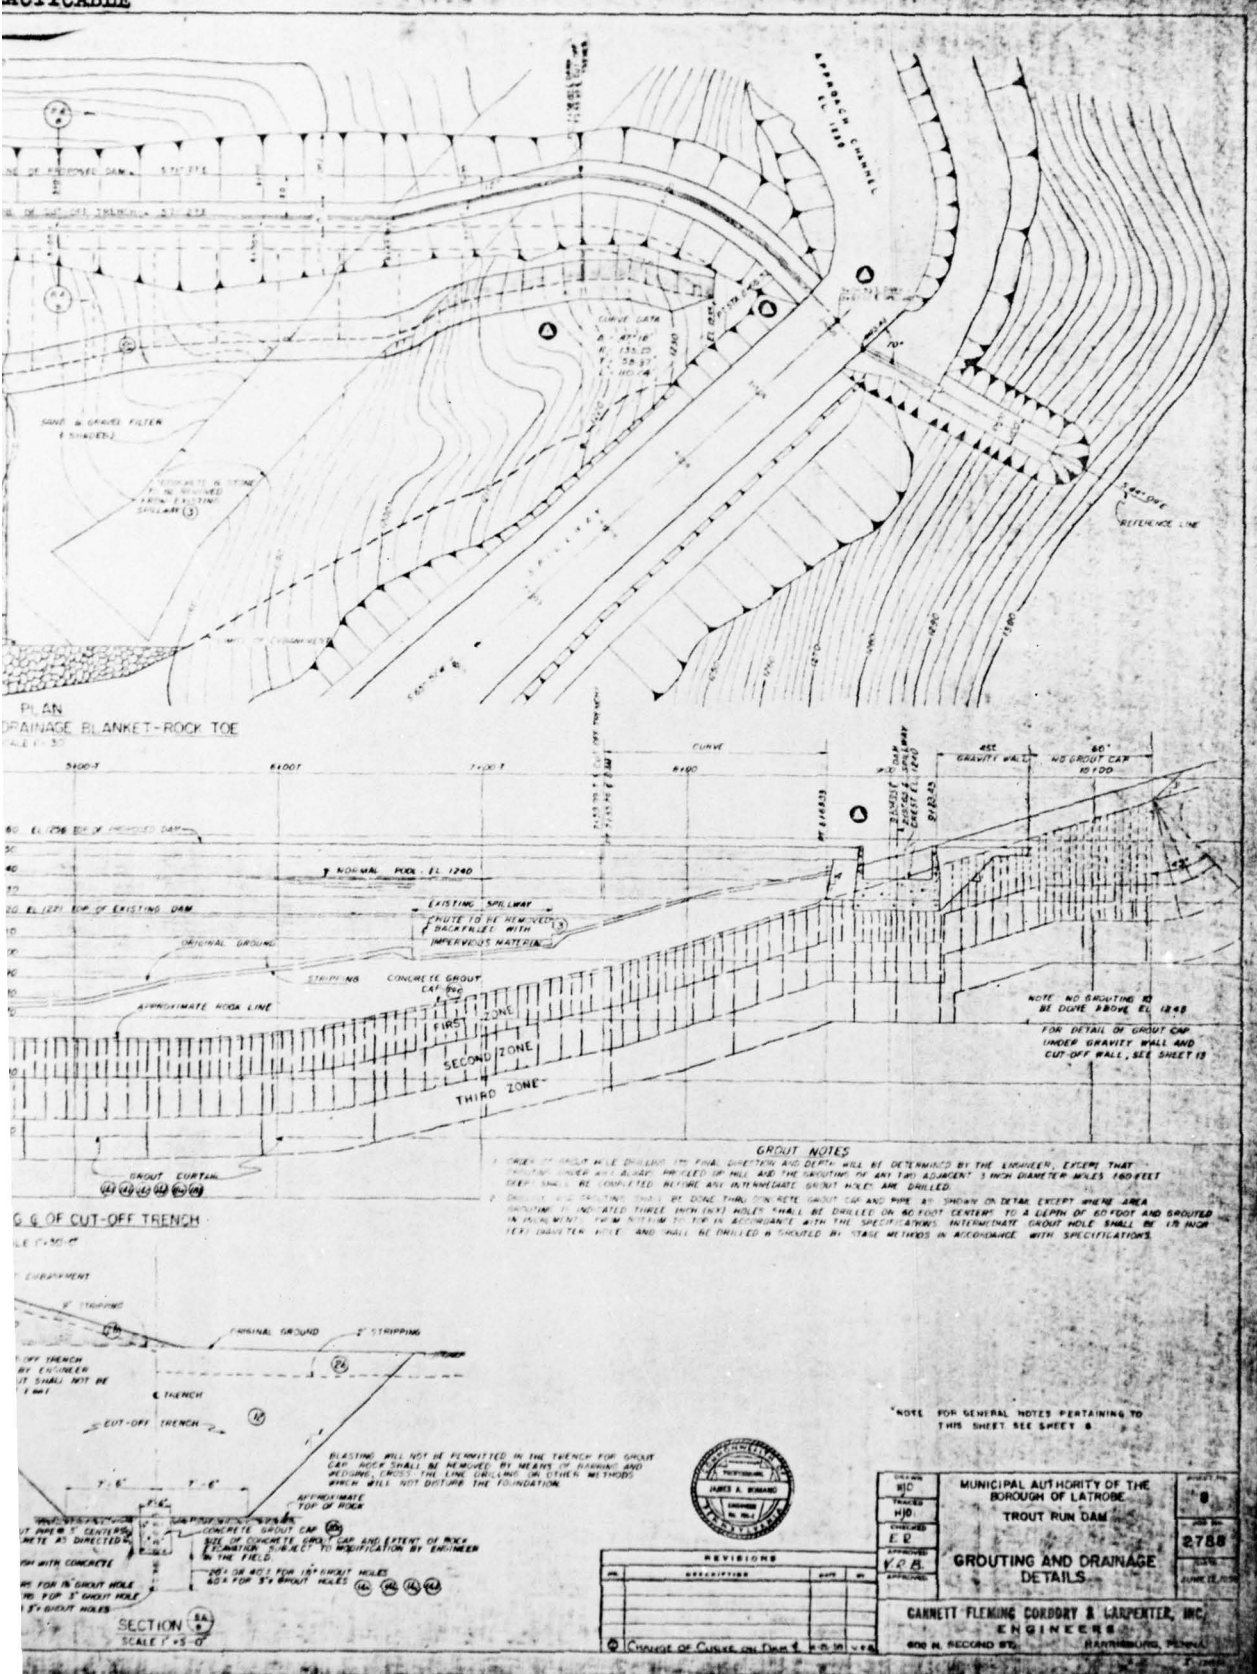
FIGURE 4

The ogee spillway foundation is keyed into rock on the left abutment and is shown on the attached Figure 4.
